Study of the effect on manufacturing parameters on the fatigue behavior of aluminum engine mounting bracket

Hossein Khalajzadeh¹, Seyed Vahid Hosseini^{*1}, Alireza Shaterzadeh¹

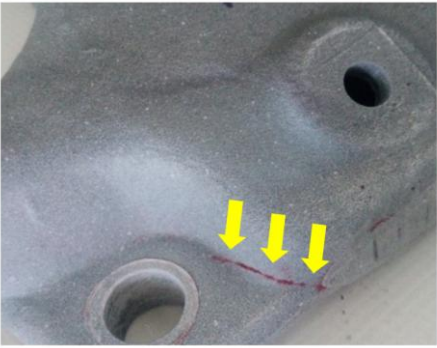
Figure 11. a) Identification of the crack in the front area of the primary sample. b) Removal of the crack in the front area of the modified sample. c) Appearance of a crack in the end area of the modified sample.

The reinforcement of the connection area of the base to the wall in the modified sample has led to the removal of the crack in this area. In order to make a more detailed investigation, after the completion of the fatigue test, a comparison of the primary and secondary samples was made by conducting a penetrating liquid test. Also, after fixing the manufacturing parameters to cause the cracks in the part, by repeating the high-cycle fatigue test on the modified sample, the crack moved from the connection area of the base to the wall to the end area of the part, as shown in Figure 11. This means that similar to the finite element results in the modified sample, the most critical region is located at point A. Table 9 shows the improvement of the modified sample respected to primary sample. As observed, the resistance of modified sample increased by 7% and scatter of fatigue results has decreased by 14%.
