Study of the effect on manufacturing parameters on the fatigue behavior of aluminum engine mounting bracket

ARTICLE INFO	ABSTRACT
<p>Article history:</p> <p>Received : 8 Jun 2024</p> <p>Accepted: 27 Sep 2024</p> <p>Published: 21 Oct 2024</p>	<p>The engine mounting bracket connects the engine to the car body and plays a key role in reducing vibrations and supporting the engine's weight and dynamic loads. It must be designed to withstand cyclic forces during normal use but fail safely in high-impact situations, like accidents, to minimize damage. This study examines how manufacturing parameters affect the fatigue performance of aluminum engine mounting brackets in cars. According to the staircase-Locati fatigue test results, the relative mean resistance load was measured at 1.24 with a relative scatter of 0.07, placing it in the unsafe operating region for the engine mounting bracket. To address this, a finite element analysis was carried out to identify critical areas on the part and implement modifications to enhance its performance. The crack initiation and growth regions observed during the fatigue tests aligned closely with the critical zones identified in the finite element an

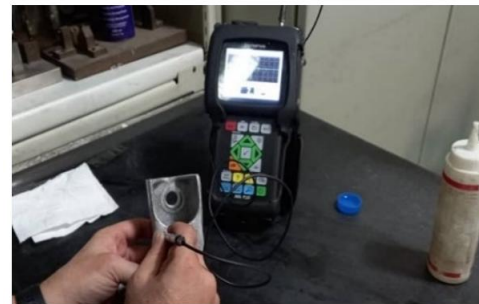
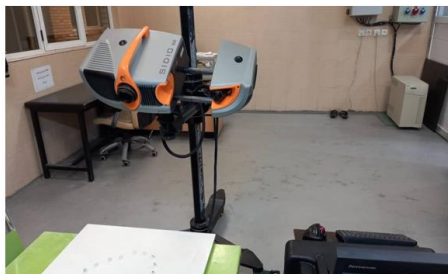
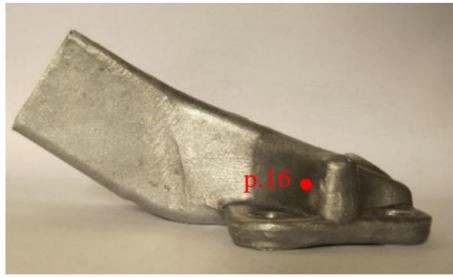
In order to investigate the reasons for the failure of the prototype in the external shell, a 3D scan was prepared by an optical device made by the Spanish company Nub 3D with a 1.5-megapixel camera lens. Also, the obtained data was entered in the SolidWorks software for the purpose of 3D modeling, which is shown in Figure 7. Finally, with the investigation, it was found that the outer shell of the initially produced part matches with the main designer of the part, so the outer shell of the part cannot be the cause of failure. After examining the outer shell, the thickness of the wall of the produced part was examined by the ultrasonic device made by the American company Olympus, model 38DL-Plus. After obtaining the thickness of the produced part, it was found that in some parts of the wall, such as point 16, the ultrasonic device shows less thickness, but referring to the reports after the test, no cracks were observed in these parts. As shown in Figure 8, the low thickness in these parts cannot be the reason for failure in the part.

Figure 8. a) Ultrasonic thickness measurement. b) The graph obtained from the thickness measurement results of the prototype. c) Location of point 16 (Minimum thickness).

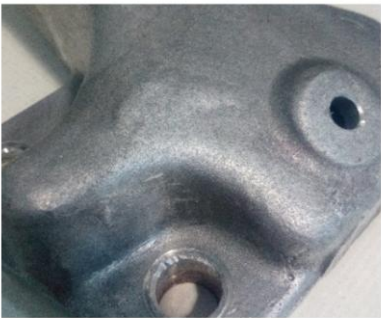
The reinforcement of the connection area of the base to the wall in the modified sample has led to the removal of the crack in this area. In order to make a more detailed investigation, after the completion of the fatigue test, a comparison of the primary and secondary samples was made by conducting a penetrating liquid test. Also, after fixing the manufacturing parameters to cause the cracks in the part, by repeating the high-cycle fatigue test on the modified sample, the crack moved from the connection area of the base to the wall to the end area of the part, as shown in Figure 11. This means that similar to the finite element results in the modified sample, the most critical region is located at point A. Table 9 shows the improvement of the modified sample respected to primary sample. As observed, the resistance of modified sample increased by 7% and scatter of fatigue results has decreased by 14%.

Figure 11. a) Identification of the crack in the front area of the primary sample. b) Removal of the crack in the front area of the modified sample. c) Appearance of a crack in the end area of the modified sample.
