FATIGUE BEHAVIOUR OF A ROLLED AZ31 MAGNESIUM ALLOYS PREPARED BY EP AND BB CONDITIONS

Faculty of Engineering and Materials Science, German University in Cairo, Cairo.

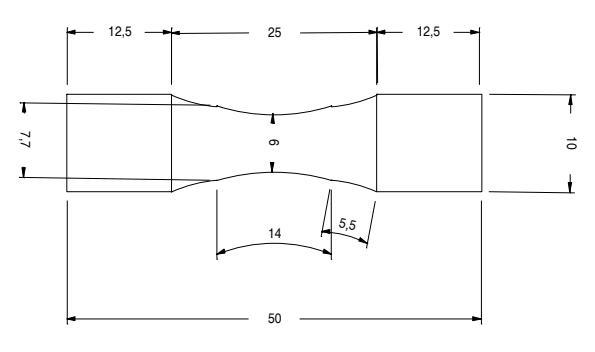
Fig. 1. Shape and dimension of mechanical testing specimens

As shown in Fig. 1. Mechanical testing tensile and fatigue specimens with 5 mm diameter, 14 mm gauge length was machined from as-received so that their axis is parallel to the rolling direction. BB condition prepared with the following preparation condition on ECOROLL instrument using tool type (HG6) at 100 bar (246 N) with feed rate of 0.17 mm/min at 30 rpm.

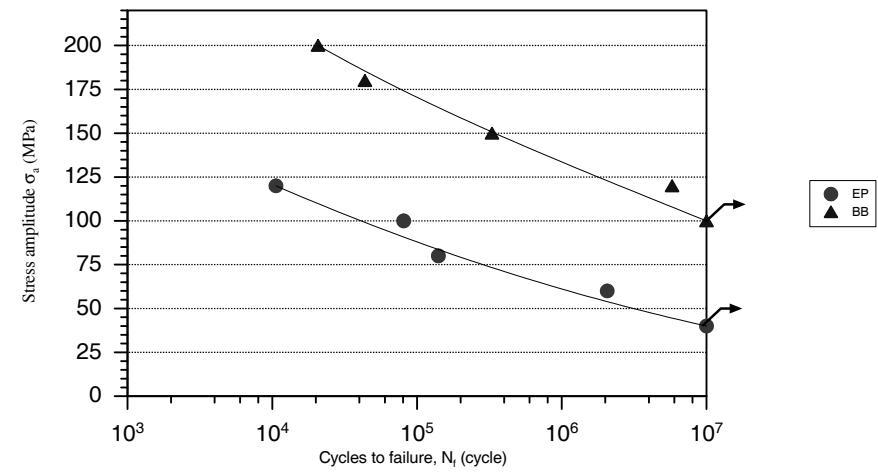
Fig.2. S-N curve for rolled AZ31 at EP,BB conditions, rotating beam, R=-1, 50Hz.

S/N curves for the EP and the BB specimens in laboratory at a stress ratio of -1 and frequency of 50 Hz (rolled magnesium alloy) in laboratory air is shown in Fig. 2. In this figure, for comparison purposes, the S-N curves of the EP and BB specimens are shown respectively. As seen from the figure, the fatigue life of the rolled magnesium alloy of EP specimen is relatively shorter than that of BB specimen. The extent bending in the S-N curve is gentler in the BB specimens than in the EP specimen. Next let us compare the S-N characteristics of the EP and BB specimens. There are great differences in the fatigue lives and in the fatigue limits, especially at higher stress amplitudes, there are differences in the fatigue lives.

The fracture surface of AZ31 for EP condition and BB condition at different stress is shown in Fig. 4. Subsurface crack initiation occurred at applied stresses at 60 MPa. At BB condition but it can be seen for both 80 and 100 MPa stress for EP condition. The S–N diagram is shown in Fig. 2. It is well known that fatigue limit does not exist in non-ferrous alloys, thus fatigue tests were continued until 10⁷ cycles. At EP condition σ = 40 MPa, fatigue failure did not occur, but non-propagating cracks were observed on the specimen surface. As can be seen in the figure, the present Mg alloy seems to possess a definite fatigue limit, which may be related to the existence of non-propagating cracks. The fracture mode depending

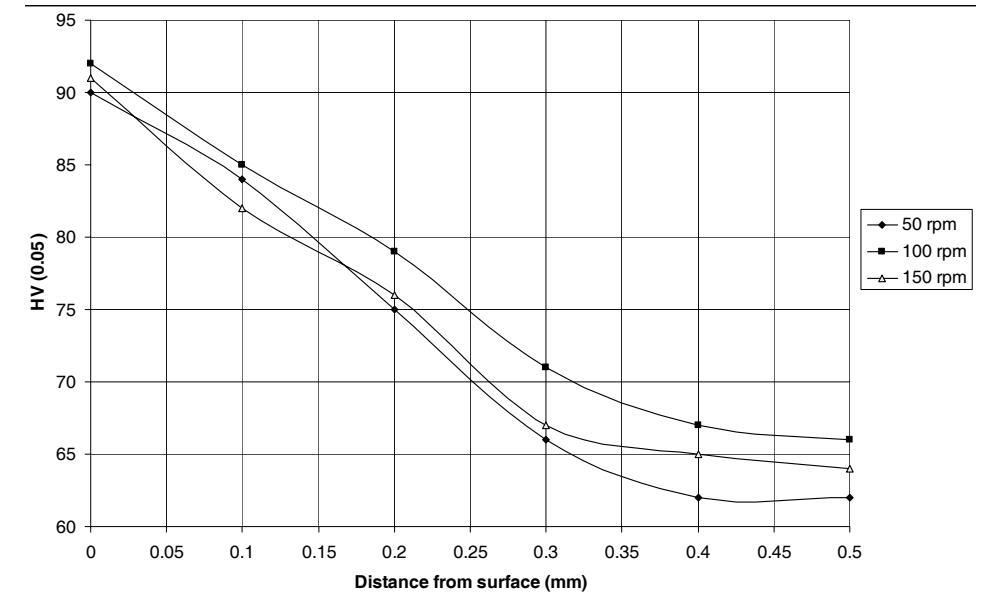
Fig. 3. Microhardness profile oif AZ31 after BB at 200 bars, 0.17 mm/min at different BB rotation speed.

3. 3. A different experiment were used to investigate the best condition for BB (pressure, feed rate, speed) as example for tool HG3 200 bar (123 N) for 50, 100 and 150 rpm. The microhardness measurement from the surface in Fig. 3. Shows that the suitable condition for using 200 bars is 100 rpm for AZ31 as the hardness decreased from the circumference gradually to the center.

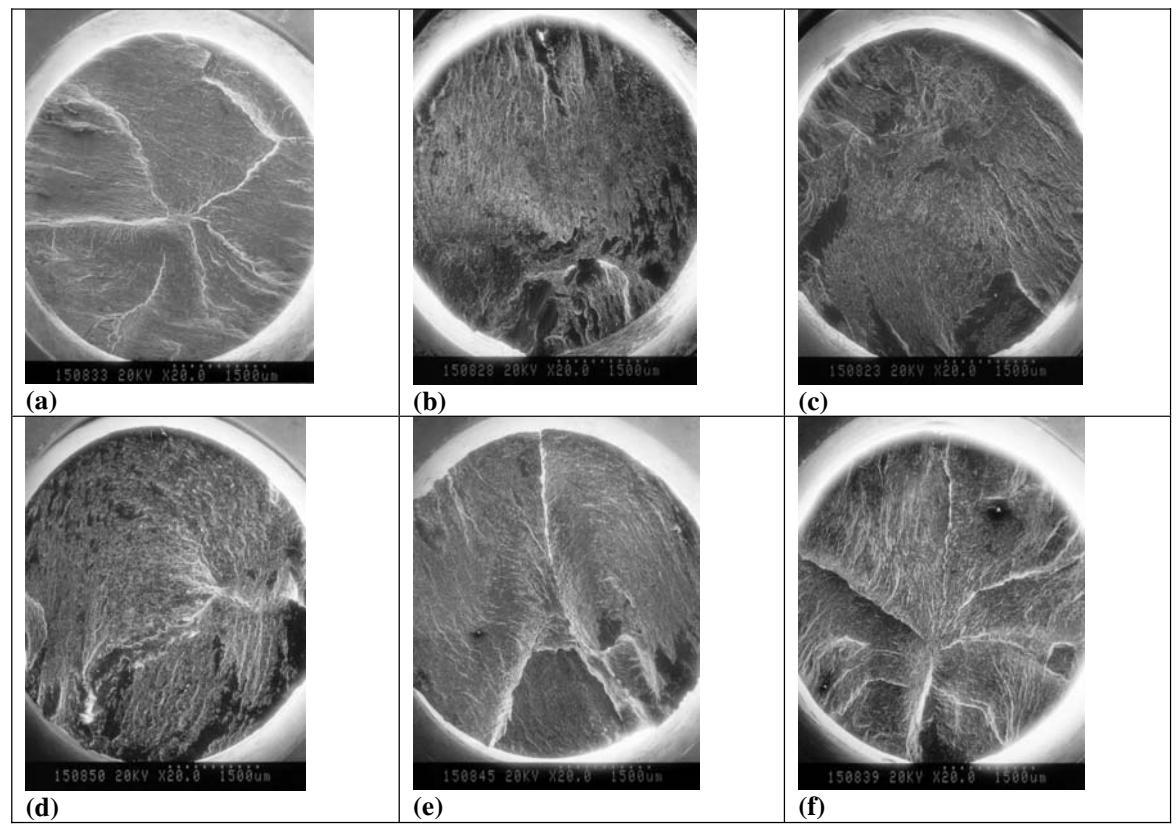
Fig.4. SEM micrographs showing fracture surfaces at difference stress for EP at (a) 60MPa; (b) 80 MPa; (c) 100 MPa and BB at (d) 60MPa; (e) 80 MPa; (f) 100 MPa.

on applied stress level, above 60 MPa cracks initiate at the surface (surface fracture), while below that stress at the interior of the specimen (subsurface fracture). Subsurface fracture is a very interesting finding, which has not been recognized in Mg alloys, for both EP and BB conditions.

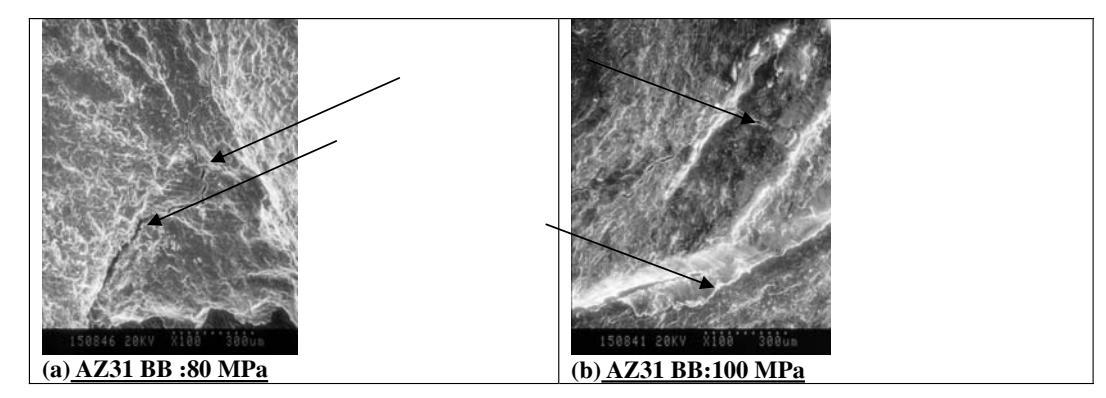
Fig. 5. SEM micrographs showing cracked surfaces at difference stress for BB at (a) 80MPa; (b) 100 MPa

The cracked line could be seen easily for higher stress for BB condition as fracture occurs in internal surface not at the outer surface as in the EP condition in Fig. 5.
