IMPROVING PITTING CORROSION OF 304 STAINLESS STEEL BY ELECTROPOLISHING TECHNIQUE

Abstract: Several surface modification techniques such as ion implantation, surface laser melting, have been employed to improve pitting corrosion resistance of stainless steel. Electropolishing is a technique in which the surface roughness is eliminated through a selective electrochemical dissolution. The effect of electropolishing on pitting corrosion of 304 stainless steel (SS) was investigated employing polarization technique in conjunction with the scanning electron microscopy examination. Electropolishing process was carried out on wire of 2 mm diameter in 70% phosphoric acid solution at room temperature for 30 min. To elucidate the effect of roughness elimination on pitting corrosion, investigation was carried out on as-received specimen with surface finishing of 60 SiC grit and electropolished specimen in 0.5M NaCl solution at room temperature. A significant decrease on passive current density and also shift of pitting potential towards noble value was recorded on electropolished specimen revealing a pronounce effect of this technique on surface modification. Further investigation was carried

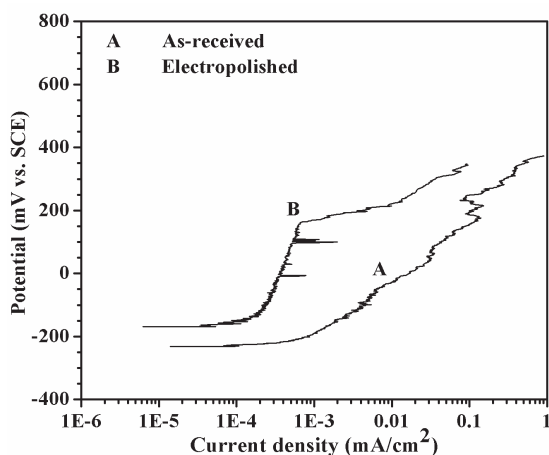
Polarization results of two 304 SS samples in 0.5M NaCl are shown in figure 1. It is obvious that by electropolishing, passivity current density and corrosion current density were decreased and pitting potential as well as corrosion potential has shifted towards noble values. For instance, electropolishing increased 100mV in corrosion potential, 200mV in pitting potential and also passivity current density decreased for a decade. In view of the fact that pitting corrosion almost begins from deteriorated zones of passivity, such as surface inclusions and etc [10-17], superior pitting corrosion behavior of electropolished sample demonstrates a more integrated passivity with fewer defects in the passivity film in compare with

Fig. 1. Potentiodynamic polarization results for electropolished (red) and as-received (black) 316 StSt in 0.5M NaCl solution and 60mV/min scanning rate

abraded as-received specimen. It elucidates that electropolishing process has a beneficial effect on pitting corrosion of 304 StSt. To evaluate the pitting corrosion behavior through metastable pit events, both of specimens were polarized from 100mV

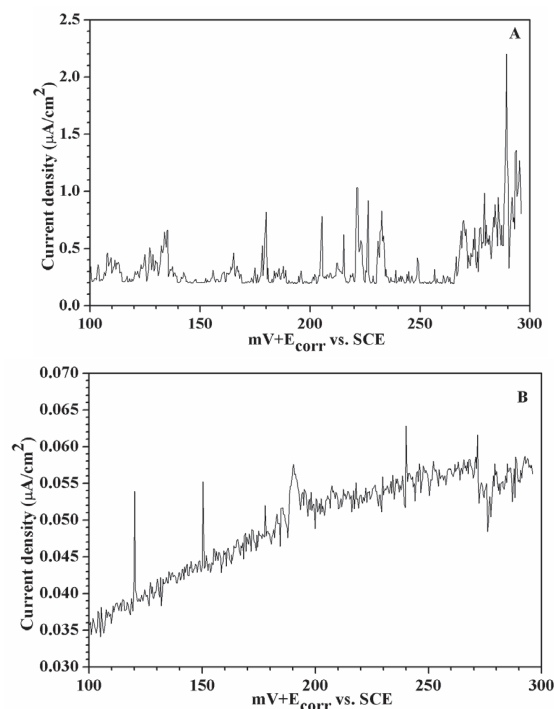
Fig. 2. Slow ramp anodic polarization of (A) as-received and (B) electropolished 316 StSt with 3mV/min scanning rate in potential range of 100-300 mV higher than E_{corr}

below corrosion potential towards anodic potentials and beyond pitting corrosion potential with a very slow sweeping rate (3mV/min). Figure 2 shows associated current density of polarization at the potential range of 100 to 300 mV above corrosion potential where the metastable pits were quiet obvious. It can be noticed that both as-received and electropolished samples were in passive state and no stable pit can be observed. However the magnitude of passive current density of electropolished specimen is much lower than abraded as-received one. Moreover decrease in the number and magnitude of metastable pits can be observed in electropolished sample. These results verify that pitting initiation sites have been considerably decreased in electropolished. This behavior was repeated in higher potentials, as an example the result of current density created in potential range of 300-500 mV above corrosion potential is shown in figure 3. It is evident that in this potential range electropolished sample still has lower passive current density than abraded

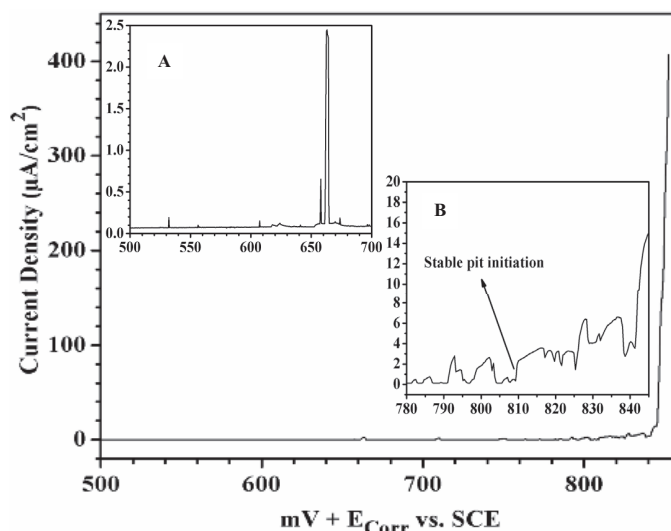
Fig. 4. Slow ramp anodic polarization of electropolished 316 StSt with 3mV/min scanning rate in potential range of 500-860 mV higher than E_{corr} (inserted micrograph A shows results in a range of 500-700 mV higher than E_{corr} and B shows potential which is stable pit initiated on surface)

as-received specimen. Besides as-received sample shows a sudden increase in its current density at 390 mV which is the indication of stable pits nucleation (inserted micrograph figure 3.a). However electropolished specimen is still in the passive state and only some metastable pits initiate in this potential range although the magnitude and number of these pits as well as passive current density are higher than previous potential range. By comparing these two potential ranges, it is apparent that current density in passive state for electropolished specimen has value of almost 100 times lower than as-received sample. To identify the pit initiation potential in electropolished specimen, the applied potential was continued to increase between 500 to 850mV above corrosion potential which is shown in figure 4. The working electrode is in passive state up to 810mV beyond corrosion potential and stable pits are nucleated at this potential. Current density was still in passive state in potential range of 500-700mV (inserted micrograph A) above corrosion potential. However the background value of passive current density and also magnitude of metastable pits was higher than two previous potential ranges. By judging against the result in noticed potential ranges for both specimens, it is comprehensible that electropolished specimen in potential range of 500-700mV has a comparable behavior of as-received

specimen in potential range of 100-300mV even though number and magnitude of metastable pits in as-received specimen in range of potential of 100-300mV is higher than electropolished specimen in 500-700mV. Moreover the results of slow sweeping potentials for these two specimens showed that electropolishing process increases pitting potential from 390 to 810 mV. It is revealed that electropolishing process in 70% phosphoric acid has considerable beneficial effect on pitting corrosion behavior of 304 SS. This method promotes pitting potential and also significantly decreases passive current density as it reported for mechanical polishing [18-21]. Moreover, the passive current density of electropolished specimen is much lower than as-received one. For instance, figure 5 shows result of potentiostatic at 400mV above rest potential on both working electrodes. The value of passive current density for electropolished sample is approximately 1000 times lower than as-received one. Additionally electropolished sample shows a current density in a range of passivity current density ($<10\mu\text{A}$) and despite the fact that as-received sample does not show pitting corrosion in this potential but its current density is not in a range of passivity current densities. Further anodic potentiostatic polarization even clarified the beneficial effect of electropolishing on electropolished specimen. For

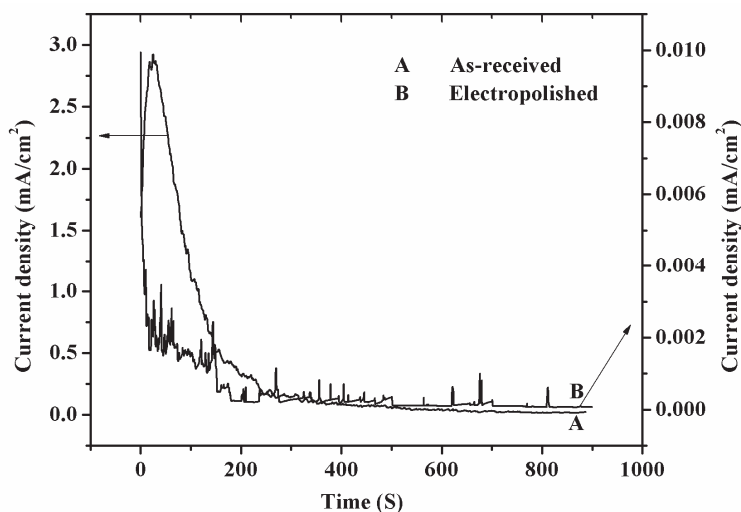
Fig. 5. Potentiostatic polarization results of (A) as-received and (B) Electropolished specimens in 400mV higher than corrosion potential

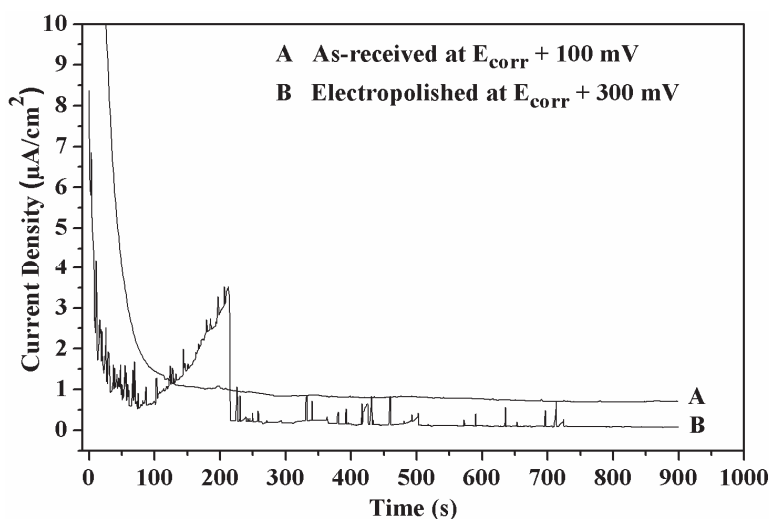
Fig. 6. Potentiostatic polarization results of (A) as-received in 100mV higher than E_{corr} and (B) Electropolished specimens in 300mV higher than E_{corr}

example figure 6 shows results of potentiostatic test in which as-received specimen was polarized in 100mV and electropolished sample in 300mV above corrosion potential. Even though electropolished specimen has been polarized 200mV more than as-received specimen but still shows remarkably lower passive current density. The reason of featuring metastable pitting current transients which can be observed as fluctuation of current density on electropolished specimens is attributed to the lower passivity current density background. When the passive current density background is very small, the

small metastable pit events can also be observed which shifting the passive current density background to a higher values; as for as-received specimen, the small events are not able to rise beyond the background and so they can not be observed.

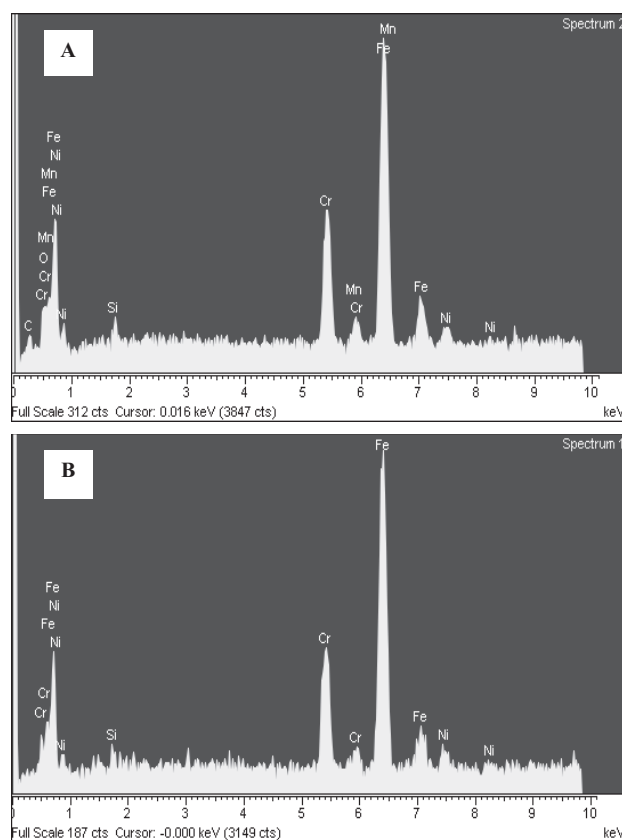
The superior pitting corrosion properties of electropolished sample can be explain by either modification in surface roughness or chemical composition changes mainly due to chromium enrichment on the surface [14-18]. EDX analysis of specimen surface is shown in figure 7. In electropolished specimen the presence of manganese is not observed and in contrast with as-received specimen its distinguishable peak was eliminated. Besides the intensity of peaks related to Fe, Cr and Ni elements have not significantly changed. Consequently the

Fig. 7. EDX analysis results for (A) as-received specimen and (B) electropolished

enhanced pitting properties of electropolished sample can be explained by modification in surface roughness and removal of MnS inclusions rather than significant chemical composition changes of the surface. In fact as it was explicated above, electropolishing may change the surface chemical composition and by enrichment of chromium, the surface creates a better passivity property with lower defects [10-14]. However in this case, although the absence of manganese in electropolished surface may confirm a surface with different chemical composition in compare with as-received one, but it suggests that the most essential reason of improving in pitting properties was modification in surface roughness and possible removal of MnS inclusions. As it reported elsewhere [22], electropolishing and acid pickling are two methods that causes manganese sulfide removal. Conclusively, electropolishing process reduces

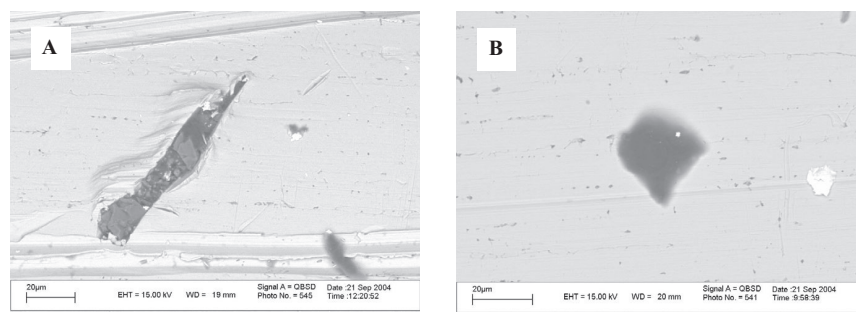
Fig. 8. SEM micrograph analysis of pit initiated on surface for (A) as-received and (B) electropolished specimen

To evaluate the morphology of pits initiated beyond pitting potential, both surfaces were analysis with scanning electron microscope (SEM). Figure 8 shows the SEM result of pits morphology on both sample surface. Figure 8.a shows that on as-received sample, pit was initiated from surface scratch which was created in polishing process by 60 SiC grit. In fact these surface scratches act as a nucleation site for pits [14-18]. During surface electropolishing, removal of surface roughness, decrease the pit nucleation sites. Figure 8.b shows the picture of stable pit which is nucleated on vicinity of remaining groove of surface scratch which may be preserved from scratches that already created from abrading with SiC paper prior to electropolishing.

These results reveals that as it elucidated in previous section, electropolishing improved passivity by modification in surface structure and removing surface scratches which were produced in surface finishing of 60 SiC grit step. Moreover another reason behind this enhancement of pitting corrosion potential of electropolished specimen can be attributed to producing a surface with lower residual stress in compare with surface polished of 60 SiC grit. In fact as it clarify
